**11nd International Conference of Mechanical Engineering
COMEC 2023
VI SYMPOSIUM OF COMPUTER AIDED DESIGN AND
ENGINEERING, BIOMECHANICS AND MECHATRONICS**

Causes of cracks appearance in fuel transport rail-tank

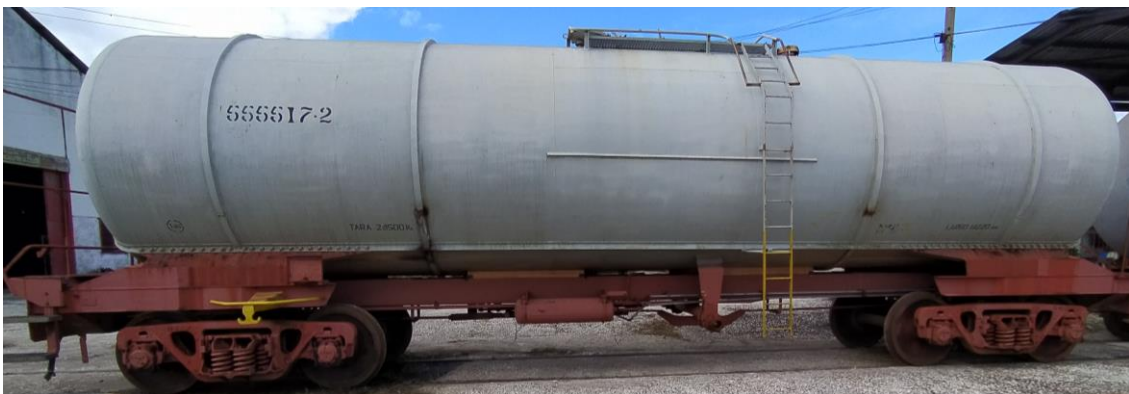
Figure 2.1 Image of rail-tank studied. Source: (author)

From in situ measurements of the rail-tank studied in the workplace (figure 2.1) and taking into account some measurements recorded in the equipment History Book [15], the geometric model was created.

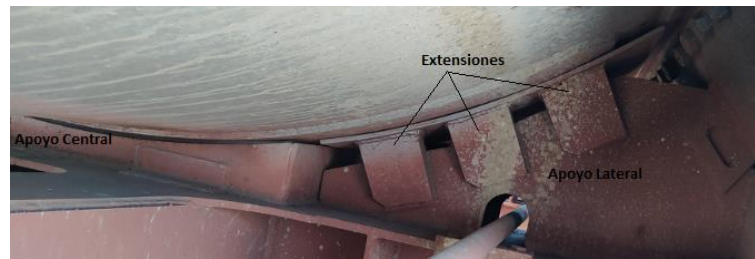
Figure 2.6 Lower supports at the ends of the rail-tank. Source: (author)

4. The lower supports at the ends (figure 2.6) do not have a design and construction according to this vessel.

As can be seen in the previous image, the saddle is divided into three parts (central support and lateral supports). The lateral supports have "extensions" to get the supports to the vessel.

The classic saddles used as supports in most vessel are integral with the appropriate dimensions so that the vessel rests completely on the saddle, generally with reinforcements. It is impressive that the supports that this vessel has were not designed for it.

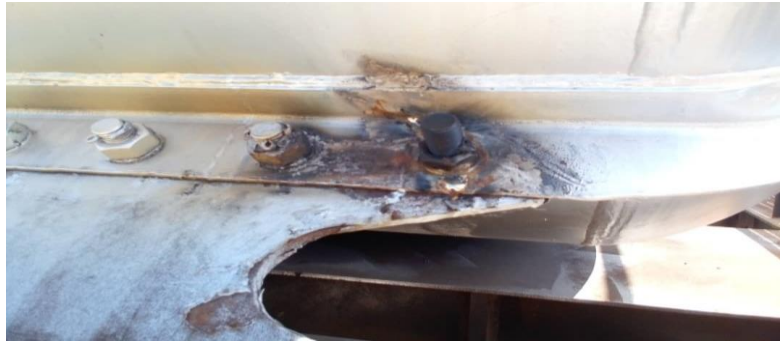
Figure 3.7 Failure zone in the extreme screw hole after repaired. Source: (Author).

As shown in the results of the previous simulations, in most cases, the maximum stress values arise at the bolt holes at the ends of the side beams which exceed the allowable stresses of the material, thus occurring resistance failure. This fully corresponds to reality, since the rail-tanker being investigated has shown notable deterioration and fractures in said areas. The image in figure 3.7 shows the deterioration and the repair that has been undertaken.

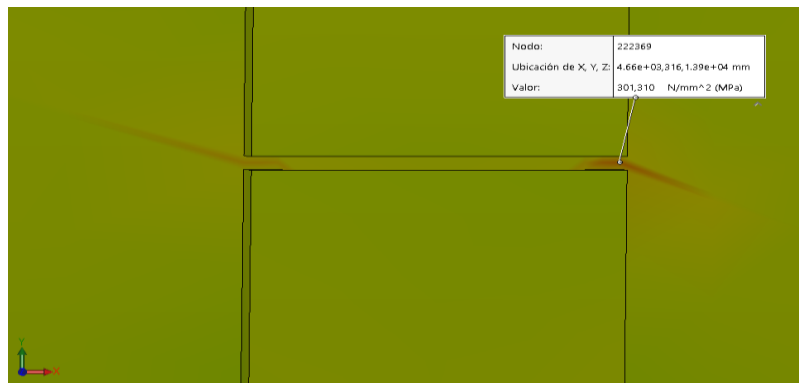
Figure 3.8 Normal stresses on the Y axis in the failure zone. Source: (author).

To analyze the failure zone, simulated from a one-millimeter gap in the tie of the rings as explained above, values are taken at selected locations. Figure 3.8 shows the analysis area and the stress value at a point in this region in the normal direction of the Y axis in an enlarged form. A maximum value of 301 MPa is observed, which is greater than the permissible value of the material (235 MPa), so the failure occurs.

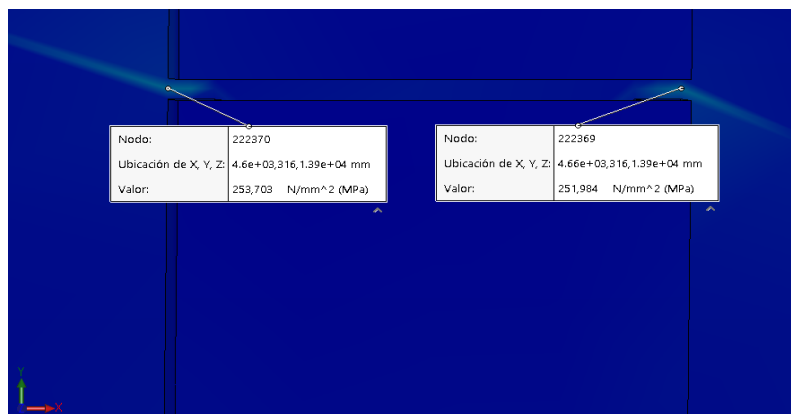
Figure 3.9 Equivalent von Mises stresses in the failure zone. Source: (author).

The von Mises stresses are also shown in Figure 3.9, with maximum values in the failure zones of 253 and 251 MPa, which also exceed the allowable stress.

The simulation reflects how when the separation of the components of the welded joint (crack) occurs, tensions greater than the permissible arise on the surface under the ring (in the shell), which fully coincides with the reality that occurs in the rail-tank studied as shown in figure 2.4 "Crack advance". The image shows the defective repair of the channel type ring (which cracked again) and the growth of the crack in the vessel.
